# An Investigation of Safety Hazards and Reliability Problems in Aerial Refueling Stores

by  
Leo D. Budd  
Fuze and Sensors Department

AUGUST 1980

NAVAL WEAPONS CENTER  
CHINA LAKE, CALIFORNIA 93555

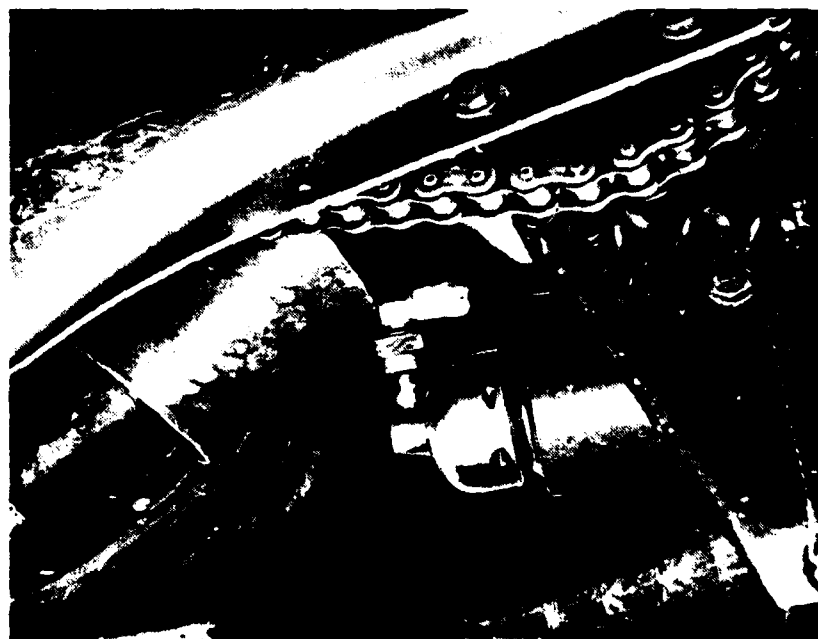
FIGURE 2. Hose Reel (Drum) Striking Guillotine Breech Cap Electrical Connector.

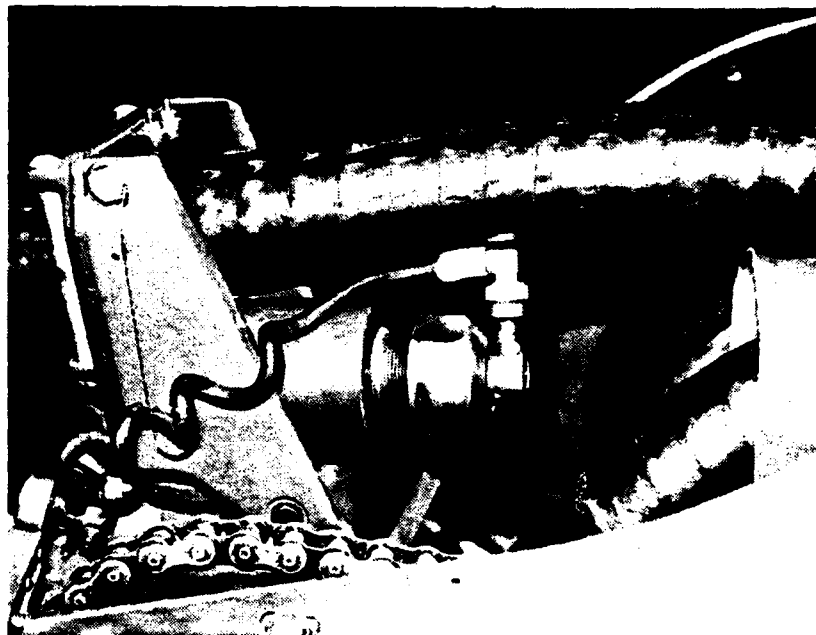
FIGURE 3. Hose Rubbing on Guillotine Breech Cap Electrical Connector.

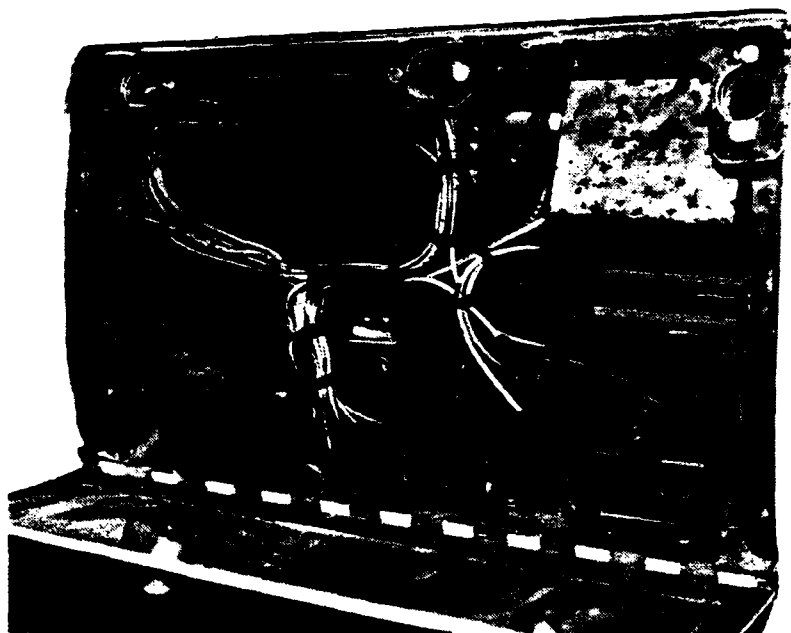
to a dimming resistor for the tailcone indicator lights (Figure 4). Most wiring was intact, and insulation on the wires was sound. The large number of spliced wires indicated several past problems.

FIGURE 4. Transformer-Rectifier Assembly; Broken Wire at Dimming Resistor.

The shorting of the transformer-rectifier, which occurs when the inductor strikes it, is a safety hazard. This could cause overheating or sparking anywhere within the store. Fire or catastrophic electrical malfunction are possible results.

replace discrete transformer-rectifier assembly components with an equivalent solid-state circuit. Informal liaison with Sargent-Fletcher Co. engineering personnel indicates that a modular device of a suitable type is currently available. It is recommended that one of these two approaches to elimination of the existing transformer-rectifier be implemented. As a short-term alternative, improved retention of the inductor is recommended to reduce the occurrence of shorting.

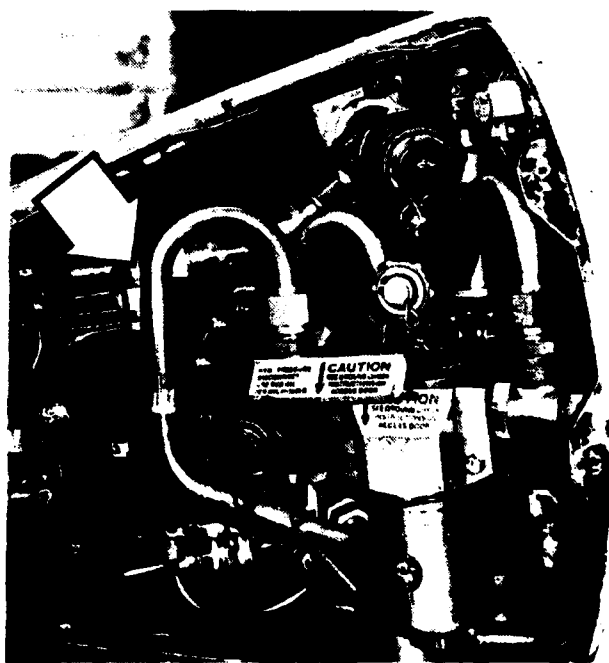
As shown in Figure 5, hydraulic fluid was leaking from one fitting at the hydraulic pump in the nose section. Several screws (bolts) used to attach the nose section access panel were of incorrect grip length.

FIGURE 5. Nose Section of D-704. Arrow indicates location of hydraulic fitting leak in Ser. No. 435.

Hydraulic system leakage warrants an effort to improve reliability. Replacement of the pump-to-filter line with a flexible hose or other vibration-tolerant part is recommended. The hydraulic pump surge characteristics should be investigated as a possible source of excessive vibration in the hydraulic system. Another line recommended for change is the real lock tube (pressure line). Other hydraulic system changes should include replacement of older design servicing disconnects and tube end fittings with newer design hardware. Replacement of MS21916-type reducers is also recommended.

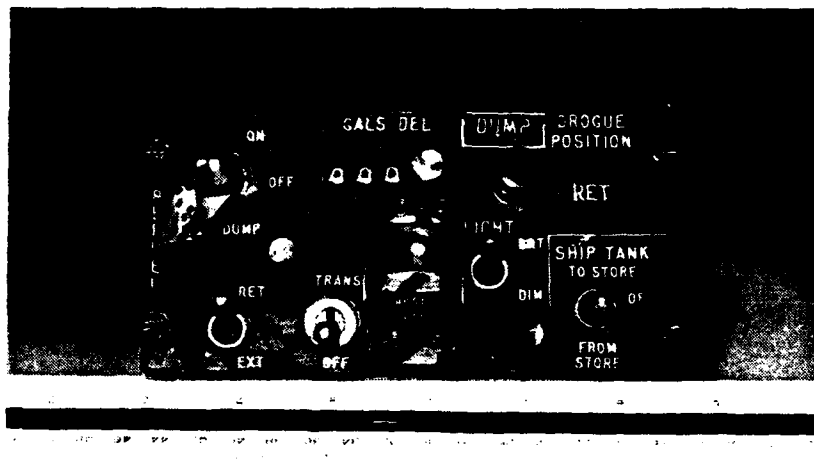
External examination of the cockpit control console revealed an unauthorized modification of the hose jettison switch guard. Safety wire had been installed to hold the switch cover in place between the sides of the guard (Figure 6). Normally, the cover rests on sides of the guard and is held only by spring tension. The wire could not be broken by finger pressure on the cover since the wire was not light-gauge shear wire. The jettison switch could not be operated without first prying this wire off.

FIGURE 6. D-704 Control Console Showing Safety Wire Installed on Guillotine Switch.

Incorporation of a new hose jettison switch to reduce unintentional hose cutting is recommended.
